Long-term monitoring of tram track crossings

Ondrej Bret, Magdalena Kreckova

Czech technical university in Prague, Department of Railway Structures

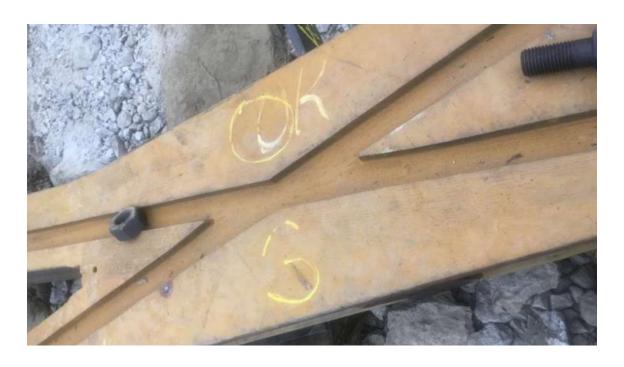
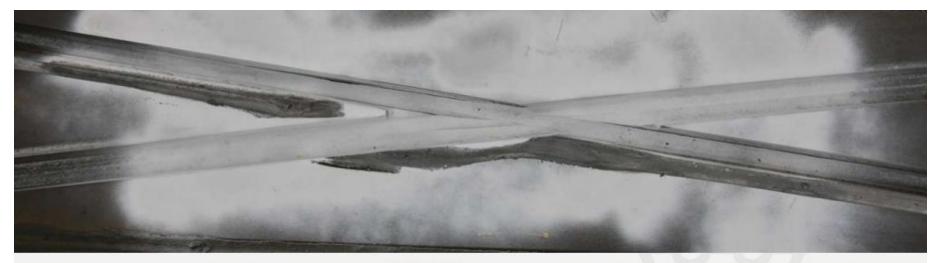
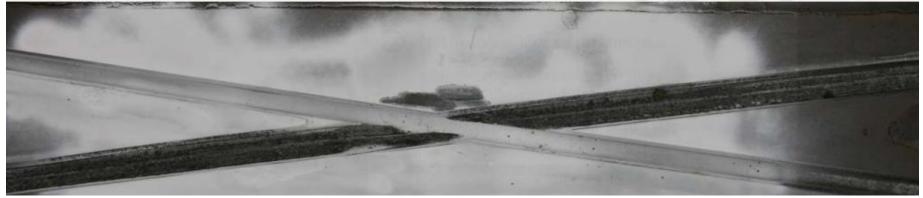
- Shallow crossing -> shallow wingey (=14 mm)
- Head loss, deformation

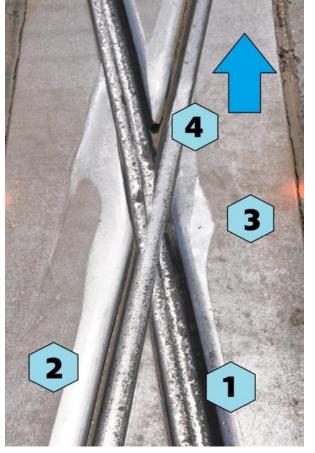
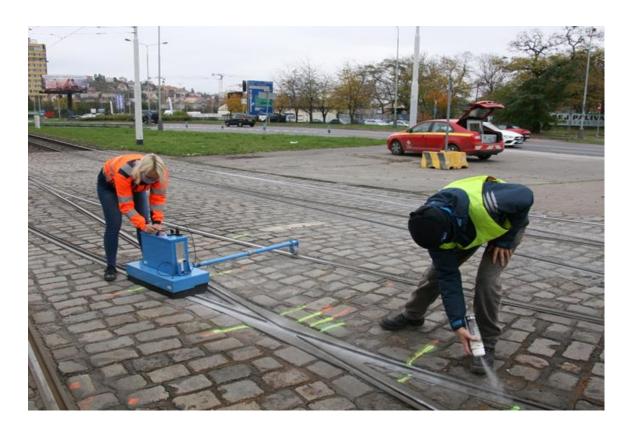
Typical defects and deformations of crossing with a shallow groove

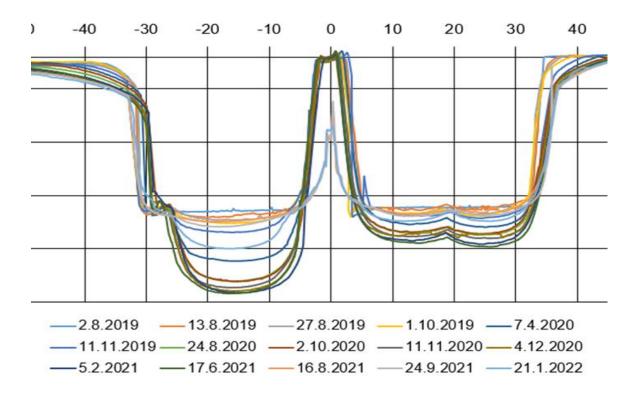
Measurement of the cross-section profile of crossing grooves

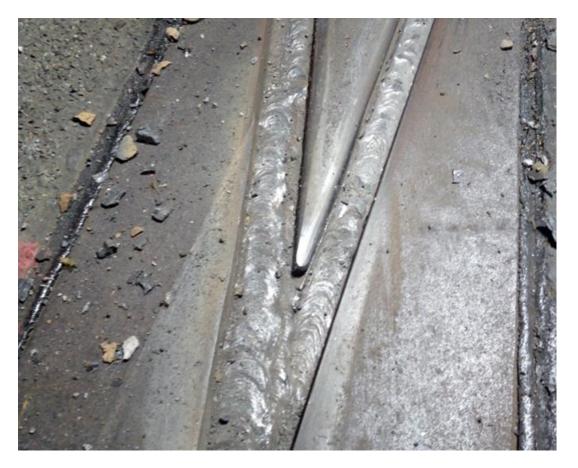
Crossing Výtoň after welding and reproflation. The transverse application of the caterpillars is noticeable

Welding and reprofiling of the crossing Vyton (12.7.2020)
