STRAHOS 2022

19th Seminar of Track Management
13 and 14 October 2022, Poprad, Slovakia

LONG-TERM MONITORING OF TRAM TRACK CROSSINGS

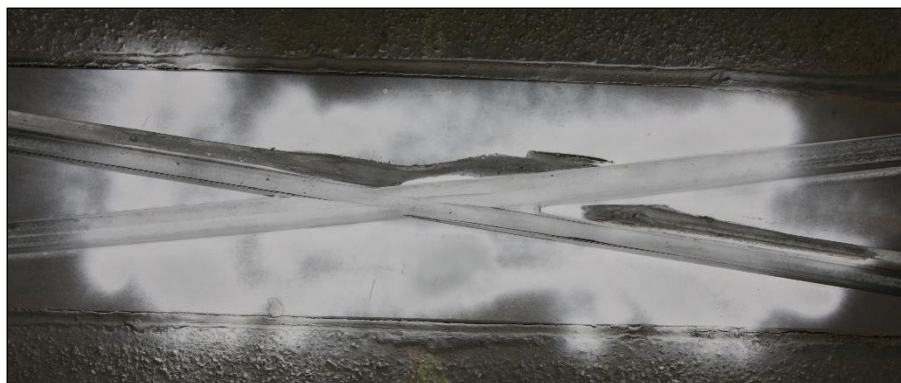
For illustration, Fig. 2 and Fig. 3 show specific examples of contact surfaces (respectively "contact tracks" of tram wheels when passing through the crossing along the top of the crossing (typical for a deep groove) and for driving around (typical for a shallow groove). Detection of contact areas, the monitored crossings were covered with a fine layer of white chalk spray, which the tram wheels wiped off on the individual contact surfaces during the passage, thus creating a contact trail.

Fig. 2 – Riding on the top of the crossing (without contact with the groove, typical for a deep groove)

From the photographs shown in *Fig. 2* and *Fig. 3*, the principle of the passage of the wheel and the difference between the passage through the deep and shallow crossing is very clear and understandable. Chalk spray can be wiped off on the contact surfaces. The picture of the crossing running along the top of the crossing (*Fig. 2*, deep groove) also shows an understandable and clearly visible effect of the width of the wheel, which comes into contact with the wing of the crossing gradually. The contact area between the wheel and the wing is visible in different widths and distances from the groove until the subsequent transition of the wheel to the vee end of the crossing and continues along the top in the direction of travel.

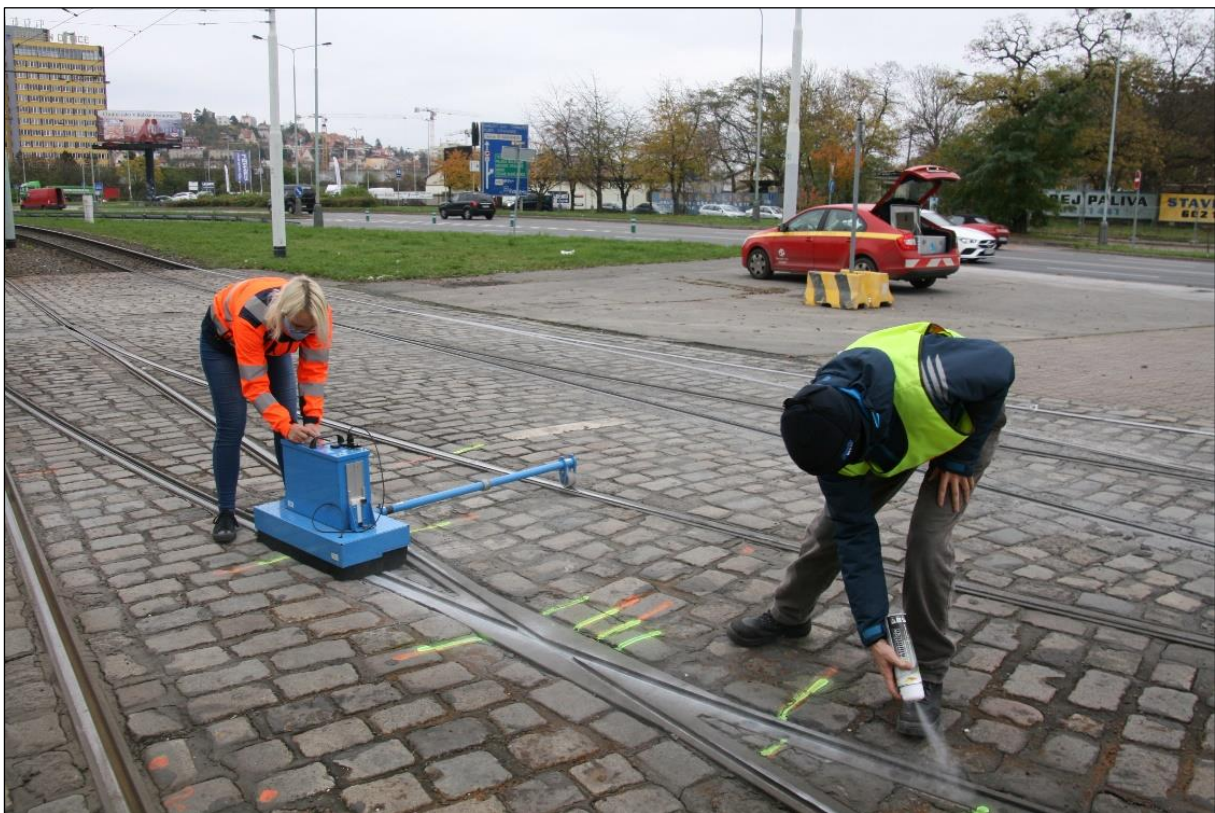
As part of the work on the project Long-term monitoring of track structures at tram junctions, in which the Faculty of Civil Engineering of the Czech Technical University in Prague, Pražská strojírna a.s. and PPTC. The monitored crossings are regularly measured by the Contour II measuring device. The Contour II device is generally used mainly for checking the lateral movement of rails in curves in the PPTC tram network, but it can also be used for checking the condition or correct design of welds, etc. The device scans the surface of rail structures using a swept laser beam and transmits digital form. This measurement takes place either continuously or pointwise. Continuous measurement scans the rail surface in a regular step - usually 3.84 mm or 5.75 mm in the longitudinal profile, 0.13 mm in the transverse profile. [1] Measurement takes place during operation, without the need of possession. An example of the measurement and the Contour II device is shown in *Fig.5*

Fig. 5 – Measurement of the cross-section profile of crossing grooves

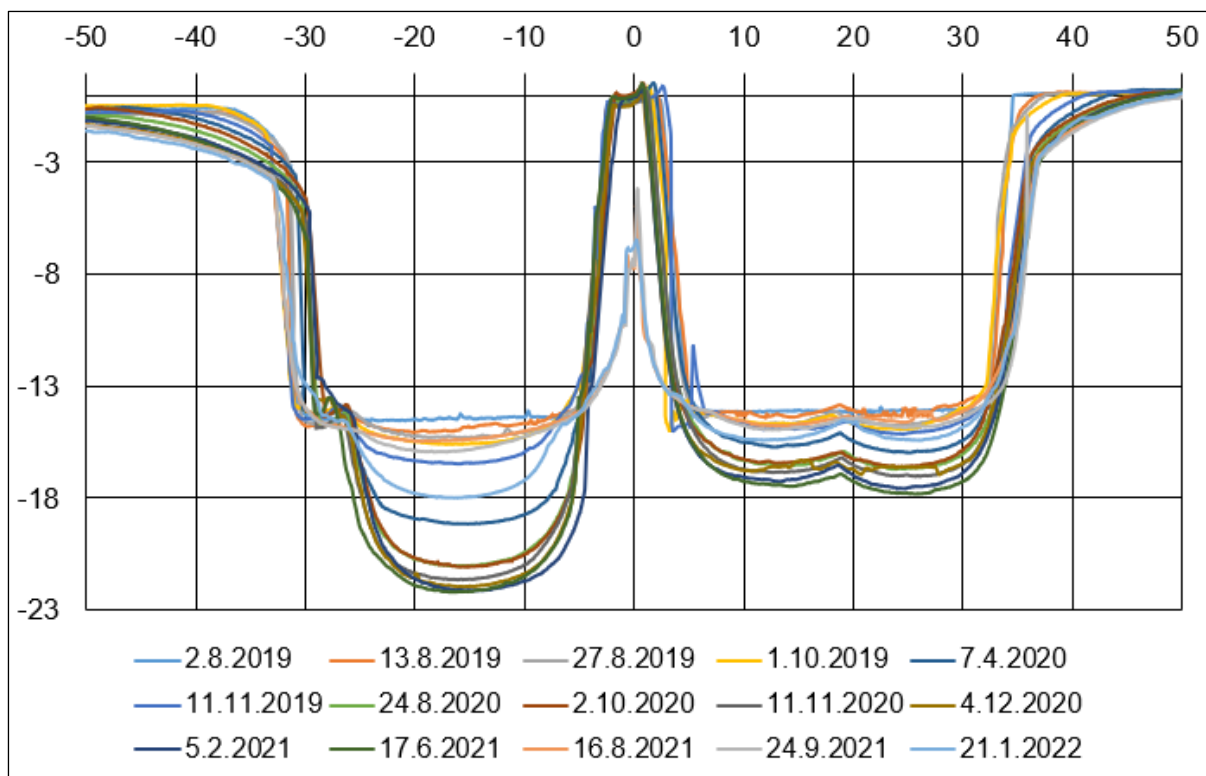
The measured data are evaluated using Contour III - Eval software. For the evaluation, 3 characteristic profiles of each monitored crossing were selected – both crossing tips and the center of the crossing. The data evaluated in this way are then compared over time, which shows the development of deformations of individual profiles over time. In the "Prague - Výtoň" locality, the construction has been monitored for 2.5 years (since August 2019). [9] The long-term development of the shape and use of the groove, showing the downhill tip of the monitored Výtoň crossing, is shown in the following *Fig. 6*.

Fig. 6 – Comparison of the condition and development of the grooves behind the vee end of the Výtůň crossing over a period of 2.5 years.

As can be seen from *Fig. 6*, due to the tram traffic, the crossing was gradually used and characteristic deformations occurred. The defects and deformations of grooves described above (and visible in the photo in *Fig. 4*) are very clearly visible on the evaluated profile. From this depiction of the development of deformation and drawback, it is evident that both grooves deepen, as well as in the junction and the formation of a "double trough" in the bottom. With regard to the method of evaluation, the junction in the evaluation is mirror - in the view on the right - compared to the reality behind the vee end on the crossing, where the arc is located to the left of the point. From the original depth of the new groove of 14 mm, it deepened within 15 months to a total value of almost 22 mm. Here we can notice the continuity and interconnection with the height of the flange of the tram wheel of the PR-K profile shown in *Fig. 1* above, and the maximum value of just 22 mm is definitely not accidental.

Furthermore, it can be seen from the illustration in *Fig. 6* this rounding also had an effect on the loss of material at the points of transition from the wing rail. There was a total height loss of about 4 mm. This use is created mainly due to the deepening of the bottom of the groove, while the trajectory for the surroundings is reduced, which puts a strain on the wing by the wheel surface.

In *Fig. 6* it is also possible to notice the shape of the groove after the performed maintenance (see next text), where the values from the measurements on 16.8.2021, 24.9.2021 and 21.1.2022 show the state and development of drawbacks and deformations after welding on 12.7.2021.

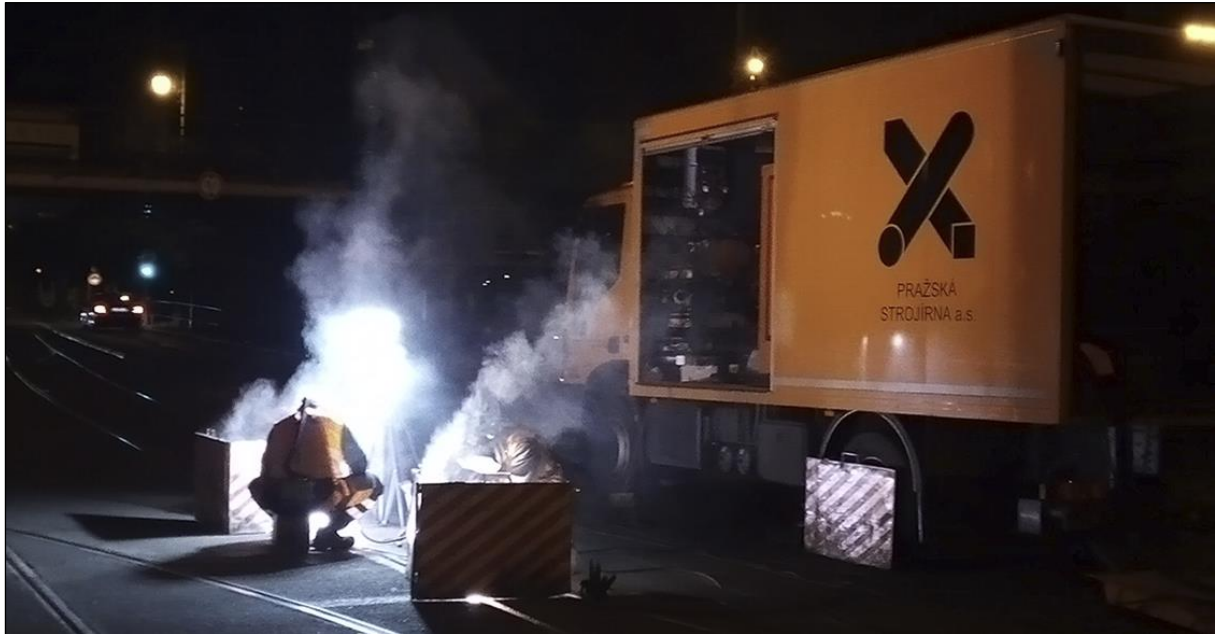
After reaching the limit state, when the depth of the groove reached the height of the new flanges (22 mm), a preventive intervention was performed - welding of new material and restoration of the groove shape, both transverse - reprofiling of grooves and spatial - remodeling of the tip (s). If such an intervention does not occur in operation, the use of the crossingworm will subsequently begin to increase over a larger area of the crossingworm, or a larger width of the wingworms. [9]

The crossing is welded so that the resulting depth of the groove is again (ideally) 14 mm.

Fig. 7 – Welding and reprofiling of the crossing Výtoň 12.7.2020

The material can be added to the crossing in two ways: longitudinal weld beads or transverse weld beads. Longitudinal welding beads are made parallel to the edges of the groove, resp. parallel to the direction of travel. Therefore, longitudinal welding is more suitable due to the dynamic shocks when guiding the flange through the crossing. The disadvantage of longitudinal welding is that it is more time consuming to perform (weld beads are long). In contrast, transverse weld beads are shorter and therefore less time-consuming to perform. However, due to the fact that they are transverse to the direction of the flange through the crossing, they cause greater dynamic shocks, which again leads (until the time of capture) to a temporarily greater stress on the crossing and higher noise emissions. Due to the fact that the welding of crossings takes place without exclusion during normal (night) operation, in practice transverse welding is preferred, because it does not limit tram traffic. The welding of the crossing is shown in *Fig. 7*, the reprofiled groove (crossing) in *Fig. 8*.

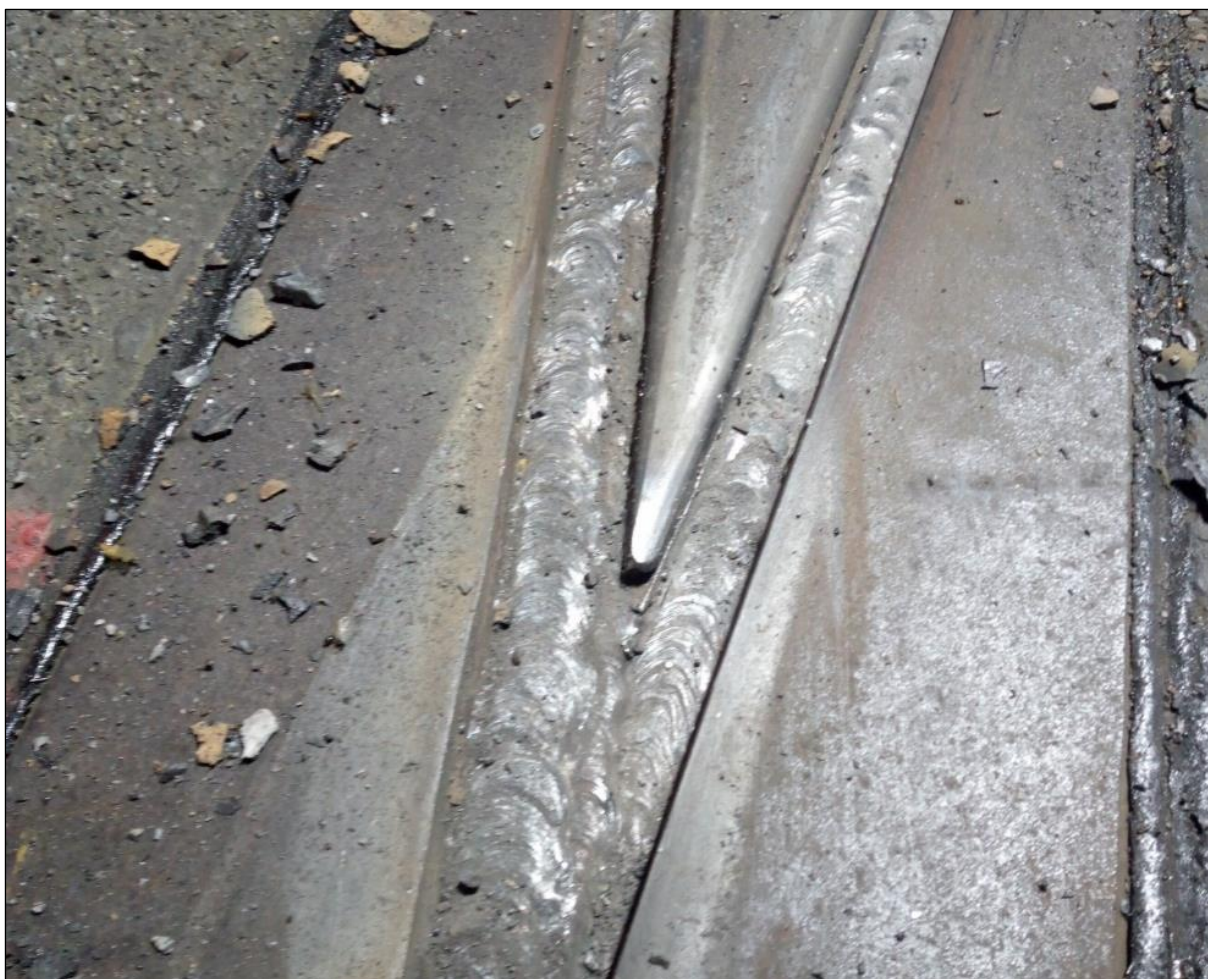
*Fig.8 – Crossing Výtoň after welding and reprofiling.
The transverse application of the caterpillars is noticeable*
